The Golf Course

Thank you for the opportunity to provide The Golf Course with our golf course water auditing services. The evaluation and testing phase was performed on October 2nd &3rd. The audit included distribution uniformity analysis, testing hydraulic pressures and evaluating the system during the day and during the nightly irrigation cycle. In this report you will find detailed facts about the different irrigation components. We include pictures, pressure charts and the results from the catch can and spacing profiles. We begin with an executive summary and conclude with our recommendations.

Executive Summary

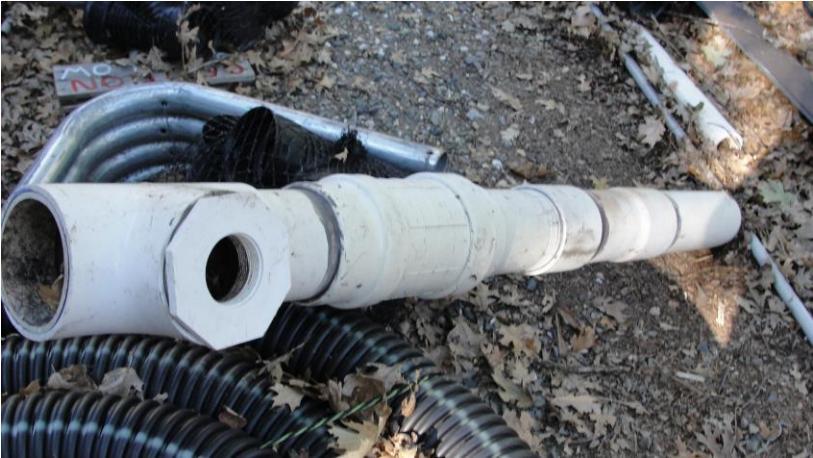
On holes four and thirteen the main lines were retrofitted in order to create a looped main line to improve system flow and pressure. Pressure improved but the 4" PVC that was used in the process has broken several times for unknown reasons. Furthermore; without calculating the hydraulic effects of these additions, there is no way to know what effect they have on water flow and friction loss. Both are important factors that have a direct correlation to system integrity and longevity.

PVC main line cracked and replaced

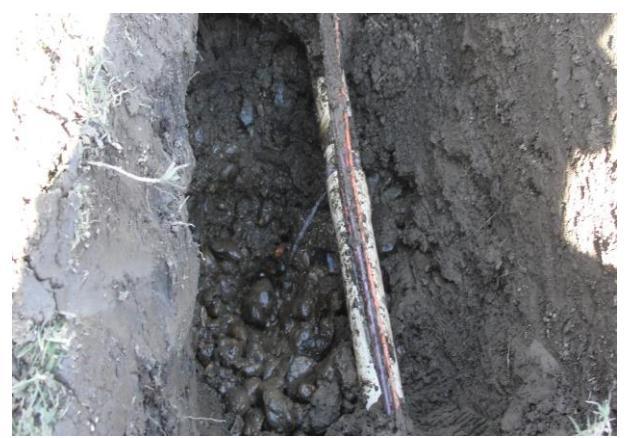
Further investigation revealed that these breaks have been common for several years and the frequency and severity worsen every year. While on site, we observed staff devoting many hours looking for a break in a lateral pipe on #17 fairway. (See picture below)

PVC pipe break on #17 fairway Water leaking into the drain pipe directly below

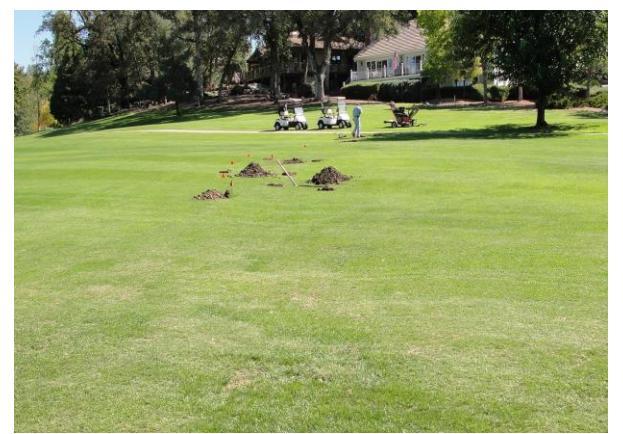
#17 fairway - searching for leak in lateral pipe

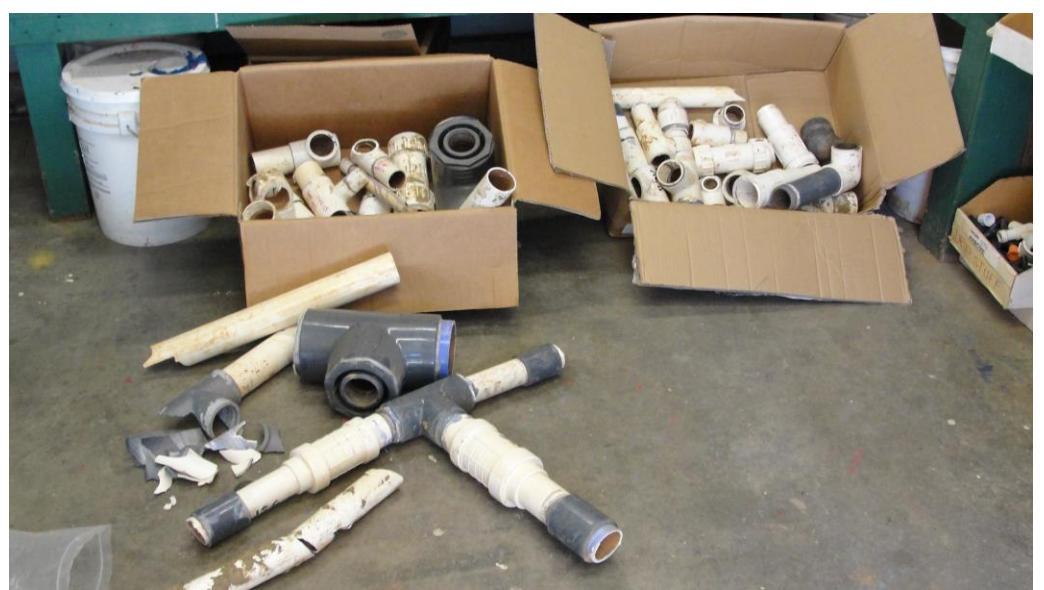
The lateral pipes are mostly 1 ½" PVC. This size pipe was probably chosen solely as a cost saving measure when it was installed in 1984. Typically 2"-2.5" is now commonly used. These sizes allow higher flows with less pressure loss while sprinklers are running. Based on acceptable velocity of flow and friction loss, the laterals should have no more than 35 gallons per minute (GPM) flowing in a lateral. This equates to running one sprinkler at a time. Based on our observation, when two sprinklers came on at the same time on one lateral, pressure dropped 10-15 PSI. Sprinkler performance was visually and measurably negatively affected. Evidence of undersized pipe and a limited # of laterals, can be found on tees 2 & 3. No more than one station can be run at the same time without a severe pressure drop. Another problem discovered with the laterals is that some of it is class 160. Class 60 is a thinner wall pipe compared to schedule 40 with a higher pressure rating. Many of the breaks have occurred in the class 160 pipe.

Some of the numerous remains from failing fittings and sections of pipe

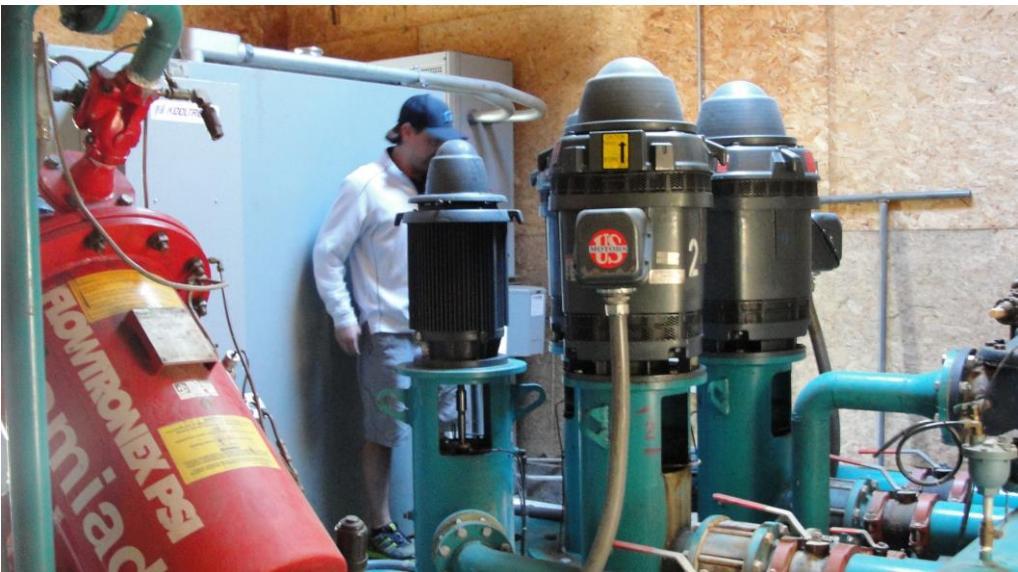
The pump station appears to be the only component of the irrigation system that does not need to be replaced. It is well maintained and looks in excellent condition. Despite being 17 years old, it has state of the art Flowtronex control panels and variable frequency drive pumps. There are a quantity of three 75 horsepower (HP) and one 30HP pumps. It also has a small pressure maintenance pump designed to keep the system up to pressure. Although staff operates the system at 1800 gallons per minute (GPM), it has the capability of producing well over 2000 GPM at 125PSI. A pump efficiency test was performed in recent years but the resulting data was inconclusive due to a flawed test. This type of test is used to create a performance base line. Data and annual testing can help determine the life expectancy of the pumps.

The Pump Station on hole #12

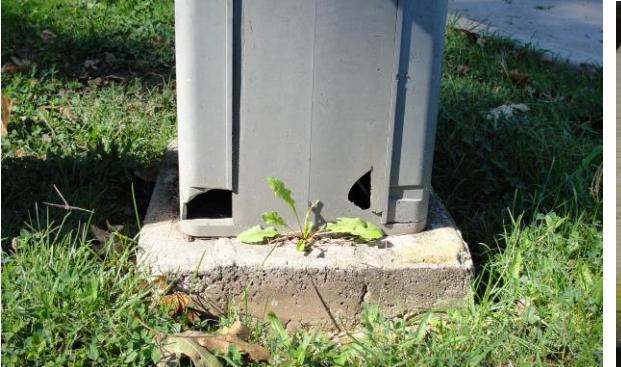
The Rain Bird satellites were installed during the partial irrigation renovations in 1995. They replaced older electro-mechanical clocks that had become unreliable. At the time, station wires were not added in order to separate stations with 2-4 sprinklers. Stations with multiple sprinklers do not provide the same amount of irrigation control as individual sprinkler head control. There are 78 satellites on the golf course. The satellites are operable and communicate to the Rain Bird central computer. The most common problem is the failure of the 8 station modules and the timing mechanisms. The modules fail at a rate of 10-12 annually. When these parts fail, the result is usually dry turf and inconsistent conditions. We also saw a couple of satellites with holes or cracks in the plastic exteriors.

Holes in the Rain Bird cabinet

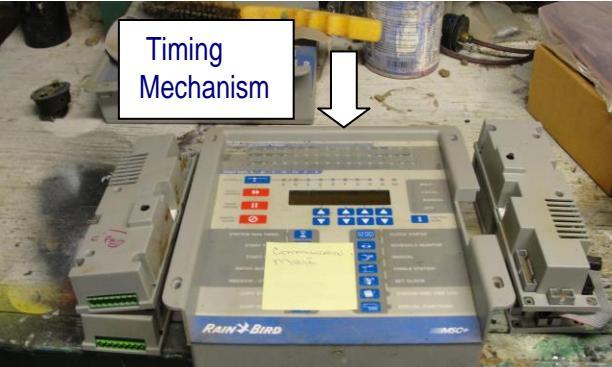
Failed 8 station modules and timing mechanisms

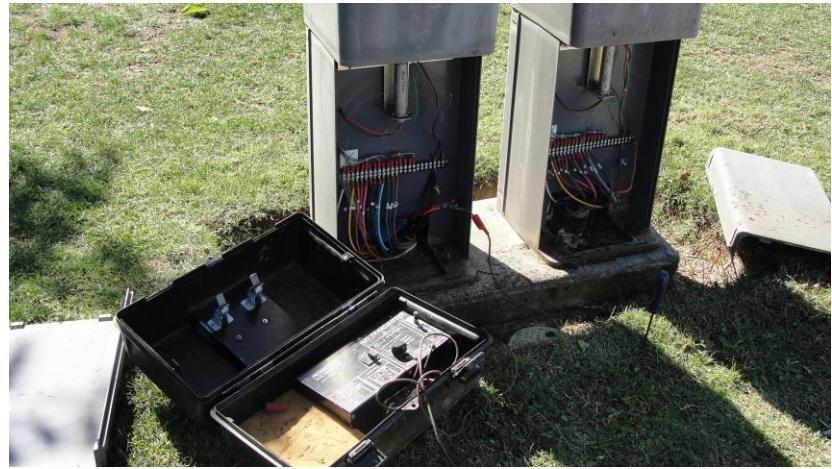
Wire tracking and repair

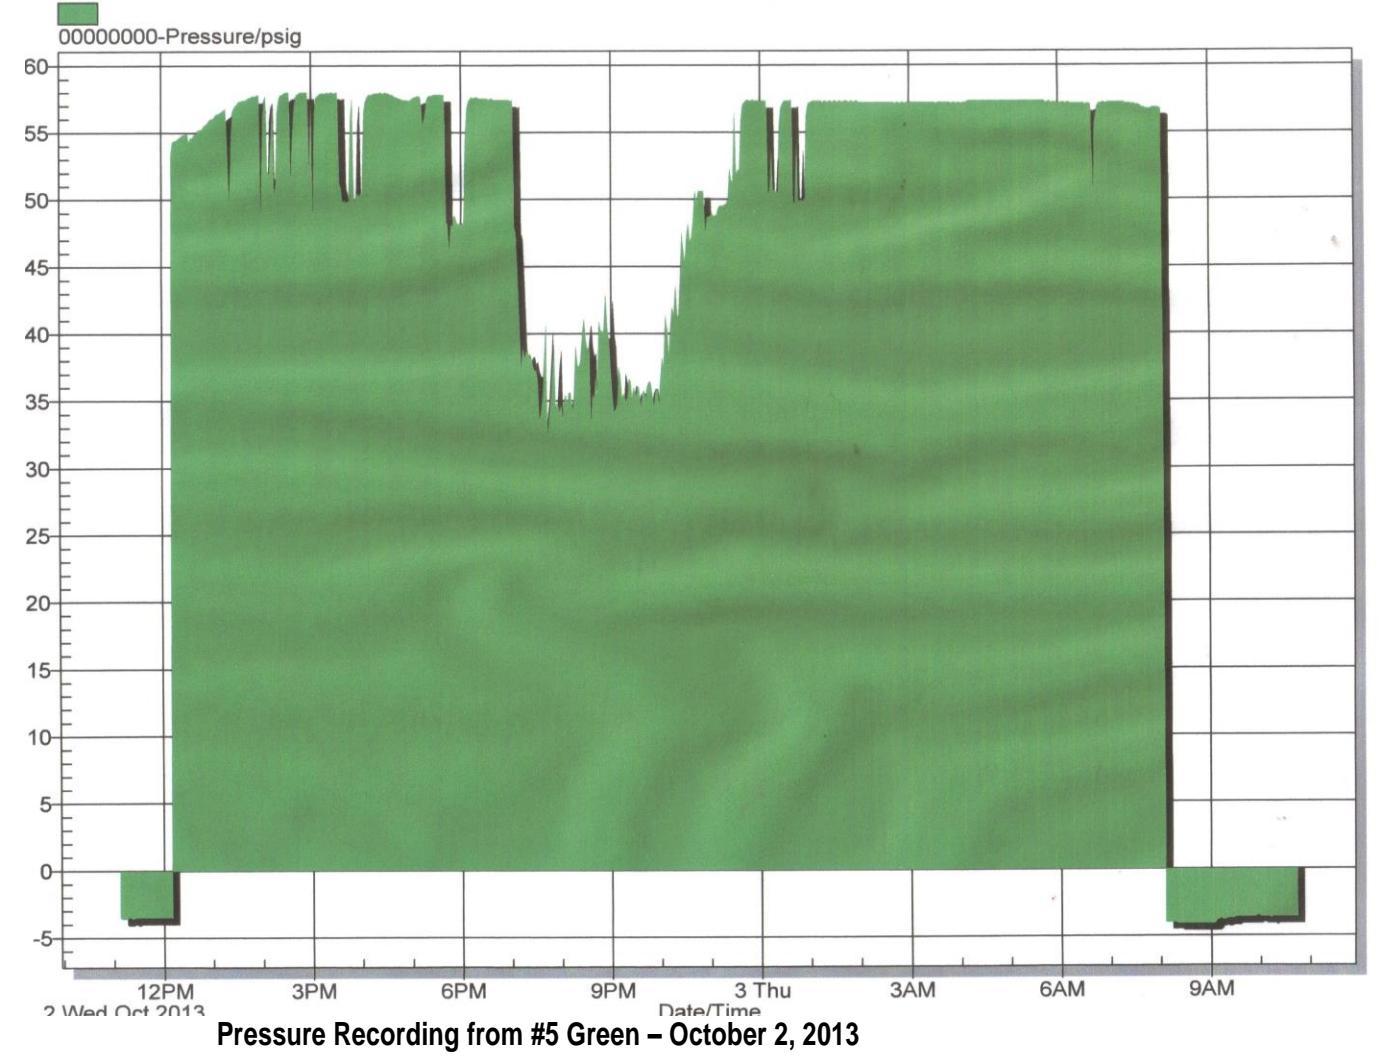
Downloaded Data - Thursday, October 03, 2013

Main line pressure was recorded on #5 fairway from 12:10 PM October 2- 8:30 AM, October 3rd. (Refer to chart on next page). The low section in the middle is the time during the nightly irrigation cycle. The pressure in that area was never above 58PSI. The lowest pressure was 32PSI and the average was 42PSI. The Rain Bird sprinklers are regulated to have pressure out of the nozzles be around 65PSI. At the current main line pressures there is no regulation. Sprinklers with lower pressures do not have the same radius of throw as they should in order to achieve the desired sprinkler to sprinkler water distribution. The water droplets become larger and tend to create more wet areas in the pattern of the sprinkler. The low pressure has become a worsening problem over the last few years. It is the main reason why it is difficult to maintain consistent turf on the affected holes.

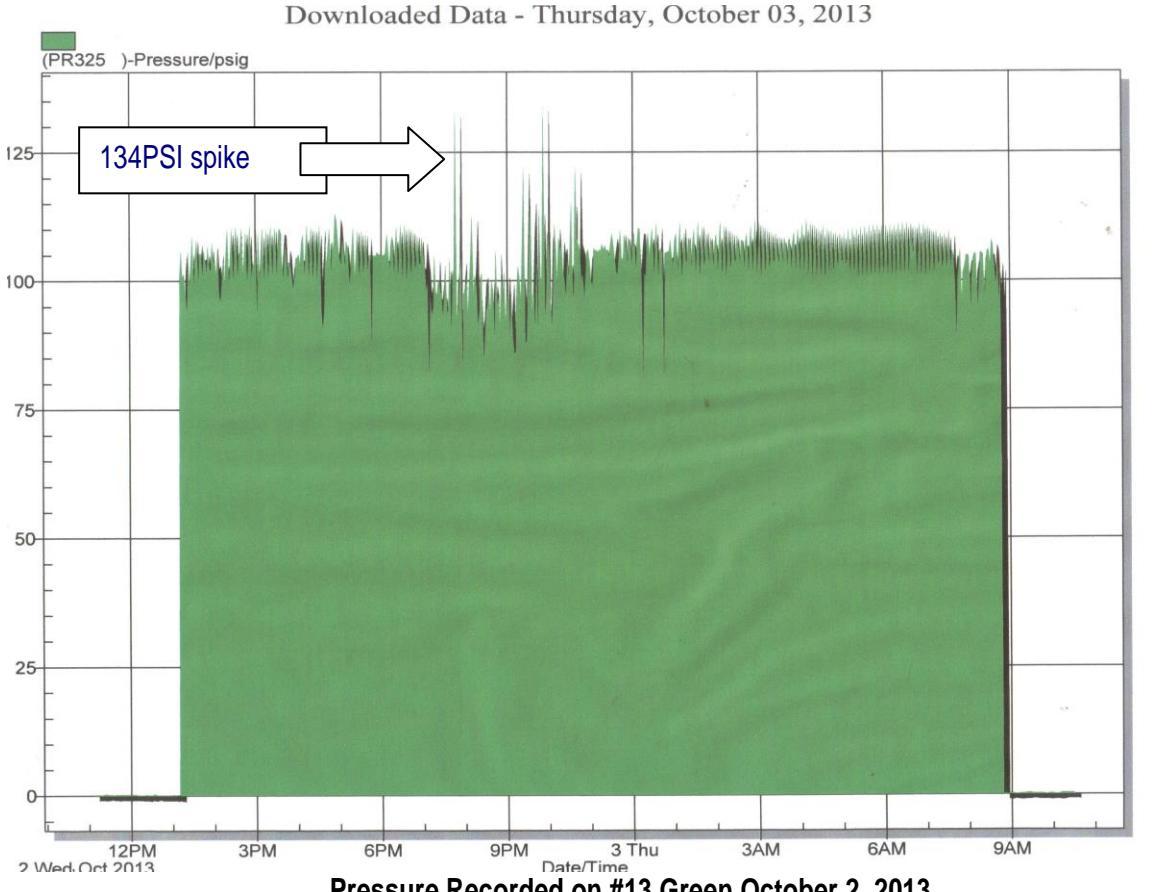
Pressure Recorded on #13 Green October 2, 2013

A second pressure recorder was placed on the main line on green #13. (See chart below) The pressure at this area was much better than the front nine. During the nightly cycle, pressure averaged 101PSI. The graph showed a low of 83PSI. The chart below reveals several spikes where pressure reached 134PSI. It is difficult to determine why these spikes occurred. A look into the central programming and timing of stations revealed no clues as to why there were spikes. The high spikes and up and down nature of pressures cause wear and tear in hydraulic systems due to water hammer. The chart also shows that there is constant cycling of the smaller pressure maintenance (PM) pump and the 30 HP jockey pump. Every six minutes one of the pumps was activating to keep the hydraulic system pressurized. This was evident even during periods where no water was running. Leaking piping and sprinklers are most likely the cause of the cycling. NOTE: It should be pointed out that in pressure tests conducted in 2008, pressure on #5 green was low and averaged about 60-65PSI. At #3 green it averaged 80-85PSI. Of the four pressure charts we viewed from 2008, all of the pressures averaged higher compared to the tests on October 2, 2013.

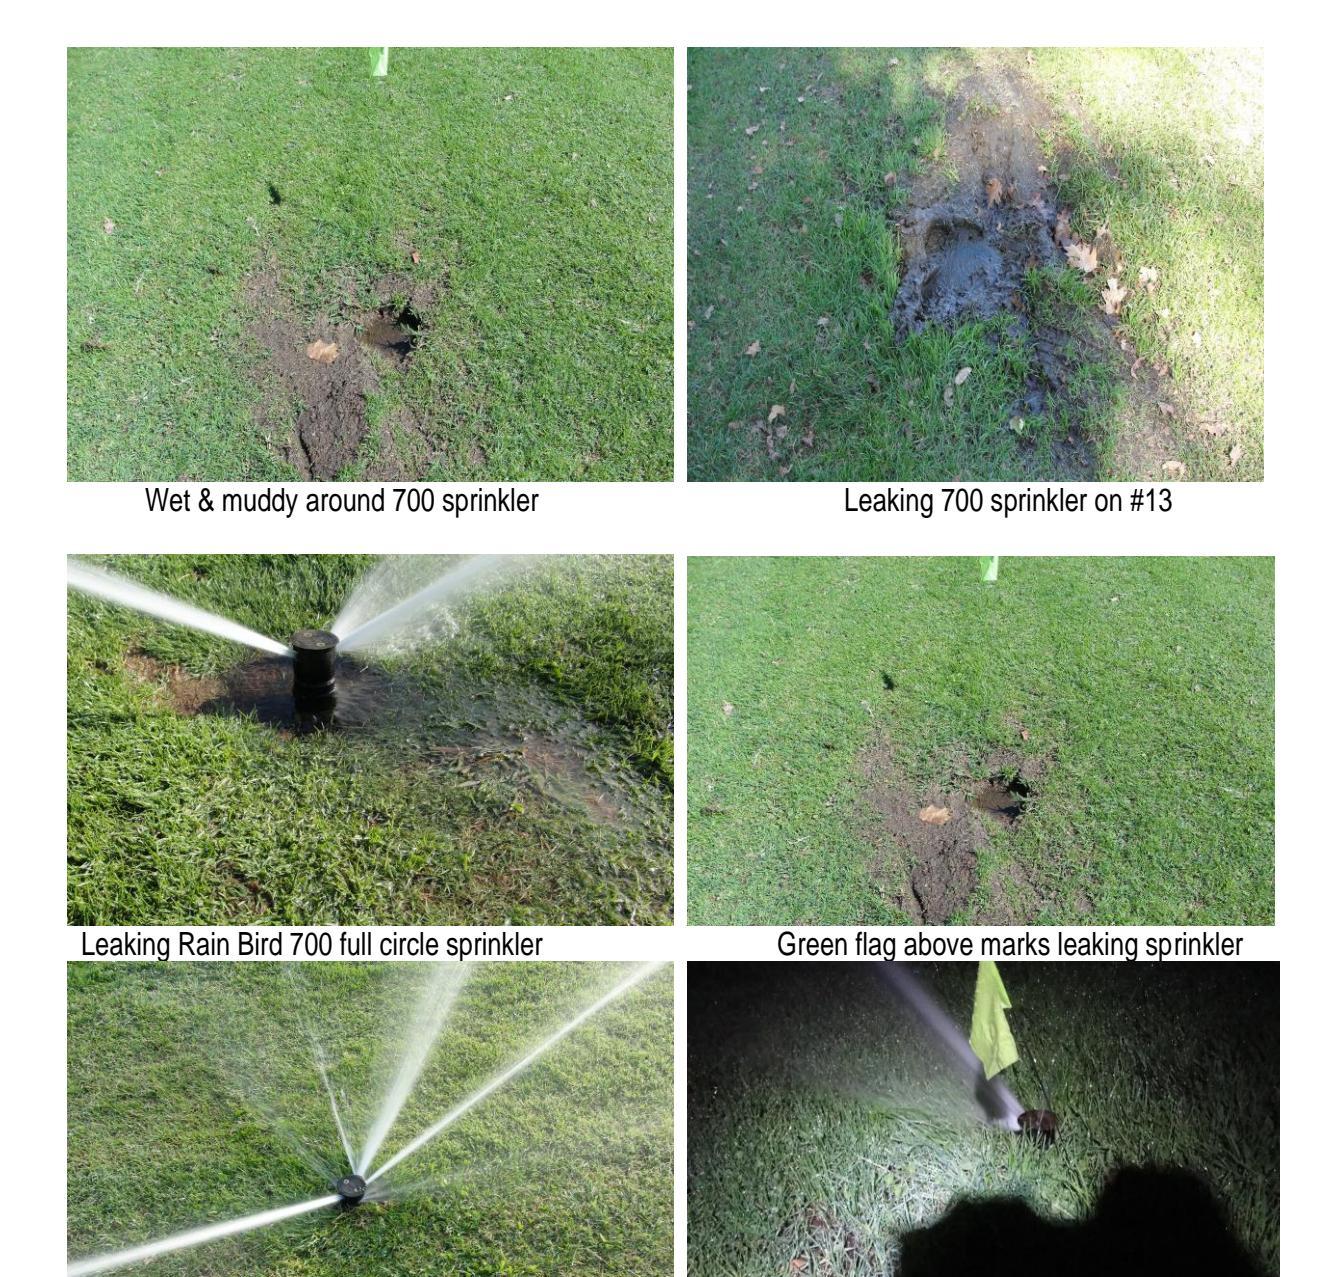
The majority of sprinklers are 17 years old. There is a significant amount of leaking sprinklers that are creating wet and muddy soil around them. (See pictures below). During the two days on site, we activated, observed or tested at least 80 sprinklers around the course. Of the 80 sprinklers, at least 15 were leaking or had some problem with the nozzle or cap. Based on the amount of sprinklers on the golf course, we estimate that over 260 sprinklers are failing and in need of replacement. Over the years nozzles have been changed in order to customize the distribution of water based on spacing and coverage. These changes in the field are not reflected in the central database. This can be one of the reasons that the pump station flow does not match the central database.

Leaking 750 at night

- 3. Inventory sprinklers & nozzles. Following inventory change central database with correct data
- 4. Following inventory and recording all problematic sprinklers, begin replacement of leaking sprinklers and document location for warranty and replacement purposes.
- 5. From inventory identify low or tilted sprinklers and begin raising and leveling sprinklers
- 6. Schedule a pump efficiency test to determine the optimum output in gallons per minute
- 7. Budget for increasing annual costs to repair the irrigation system

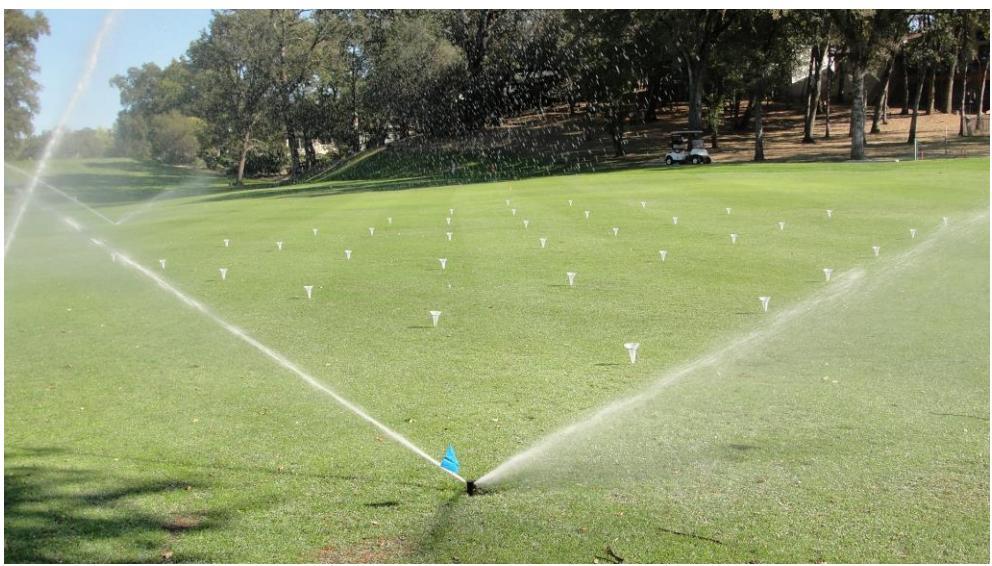
- #1 Fairway 59%
- #13 Fairway 73%
- #15 Fairway 75%
- # 5 Fairway 74% (daytime)
- # 5 Fairway 72% (night time)

Catch can test on #1 Fairway

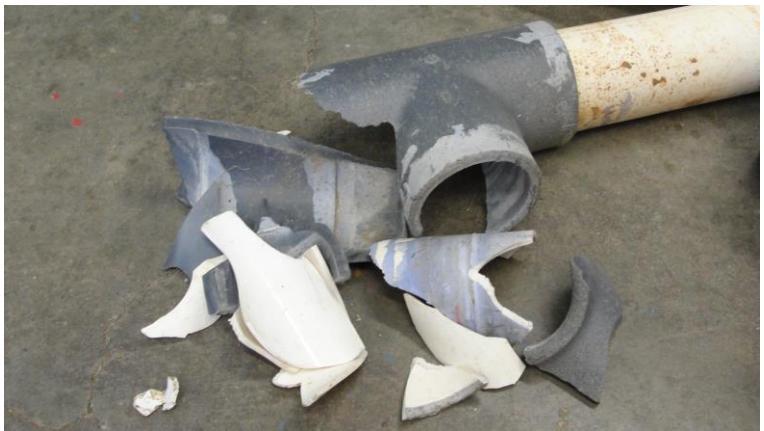
Golf course staff have kept excellent records of all irrigation breaks and repairs for fiscal 2007-2008 & 2012-2013. The majority is "T" type and elbow fittings. (See picture below). The pipe and fitting range in size from 1.5"-8".

Broken "T" fitting on 4" main line

Based on our evaluation and the age and costs to maintain the irrigation system, we recommend The Golf Course replace the entire irrigation system. The pump station does not need replacement but should be maintained and pumps tested for level of efficiency. A new irrigation system can be expected to range in cost from 1.5 - 2 million dollars. A preliminary design with cost estimates is needed to obtain a more accurate cost estimate. Should this option not be financially feasible at this time, we recommend the following short term procedures;
